**CR17 Rockslide
Update for Assessment & Mitigation
7/23/19**

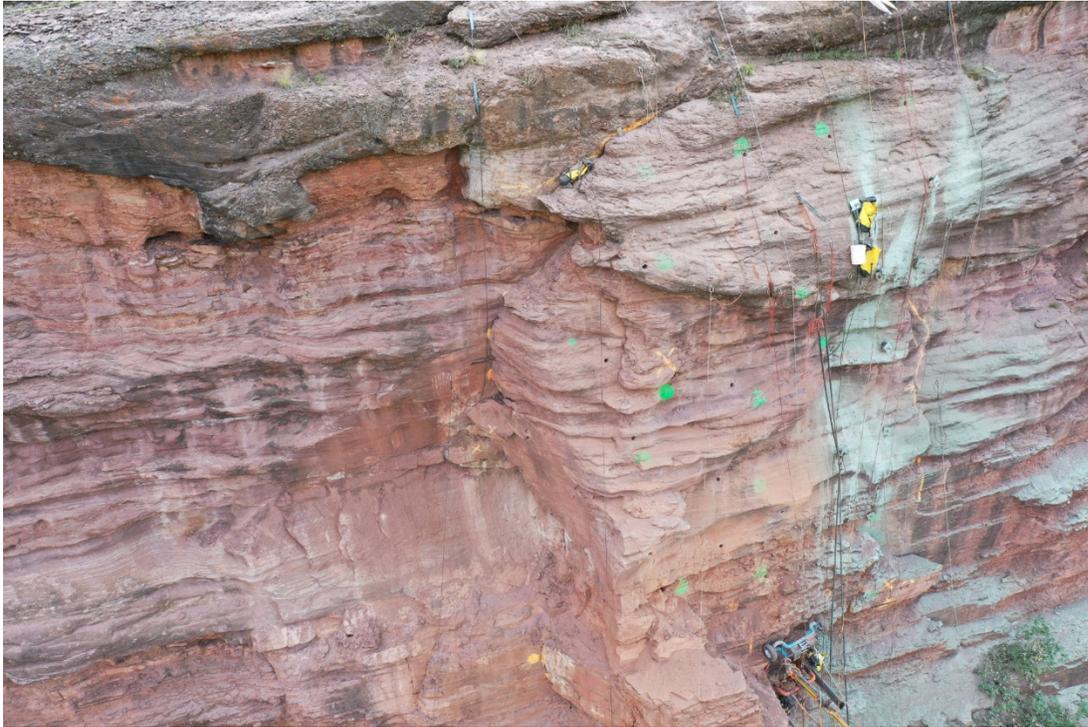
Photo 1 – Drone view of upper slab with bolts.

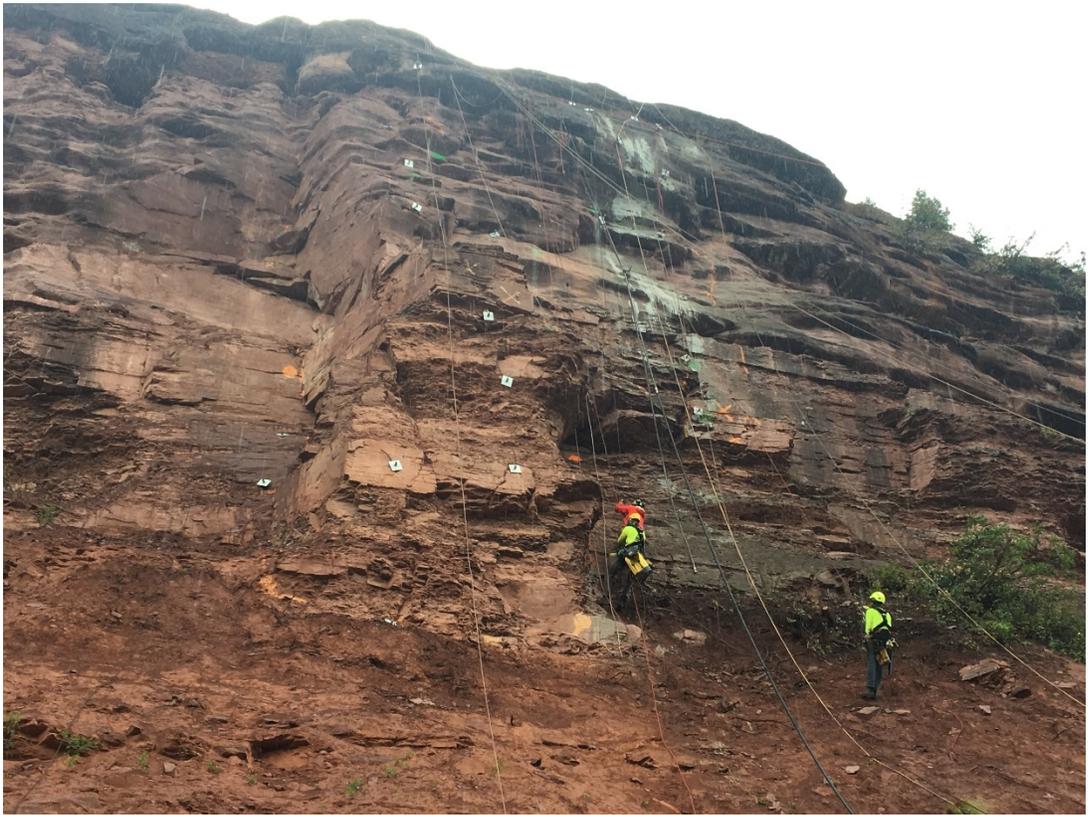
Photo 2 – Slab and footer with bolts.

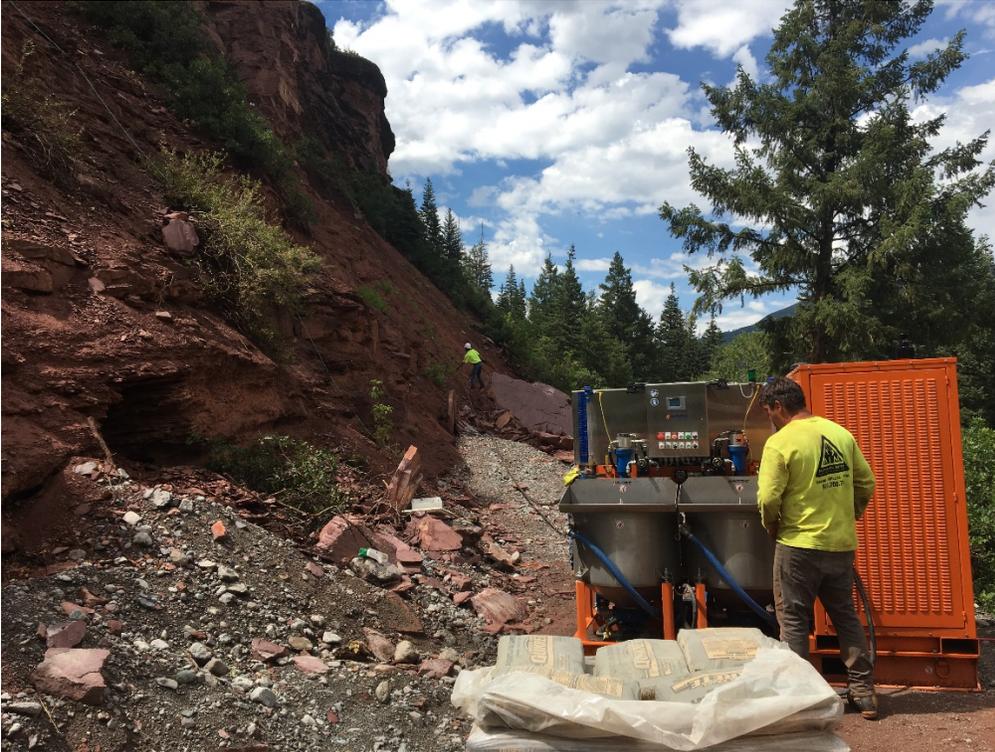
Photo 3 – Grout plant for grouting bolts in place.

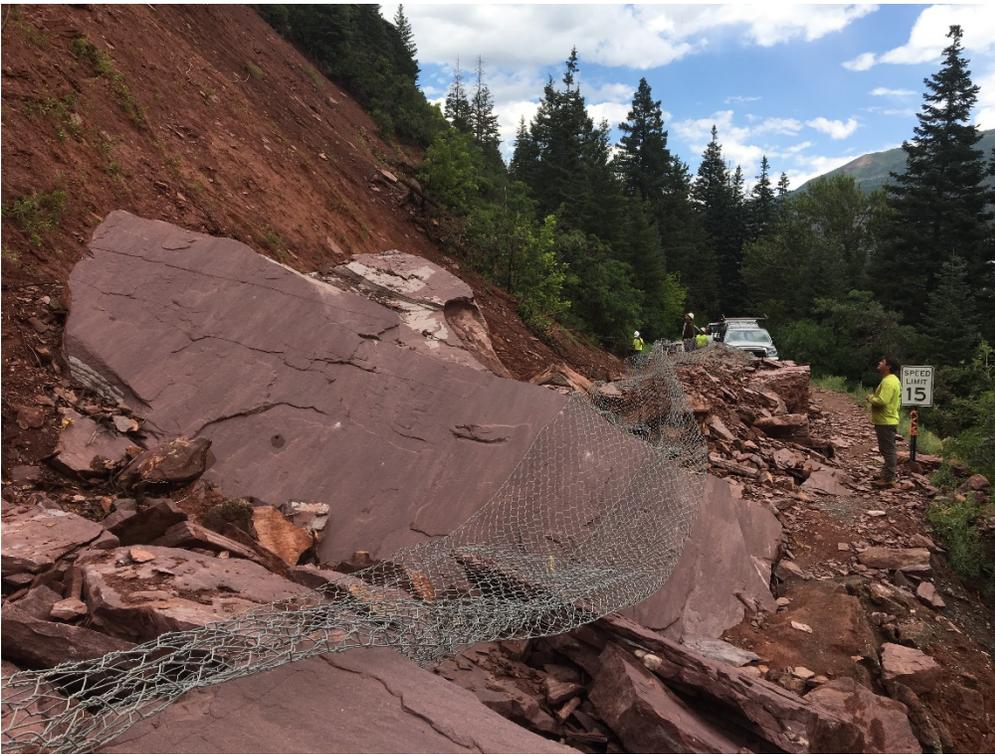
Photo 4 – Large rocky debris at base of mitigated slope.

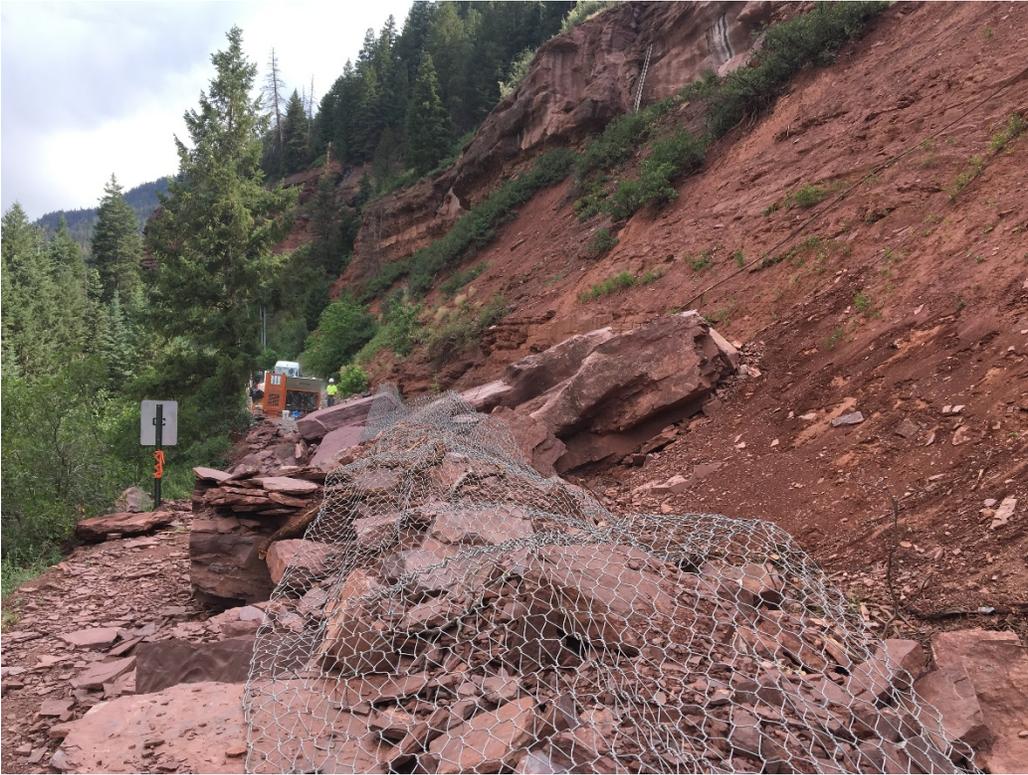
Photo 5. View south at debris on roadway.

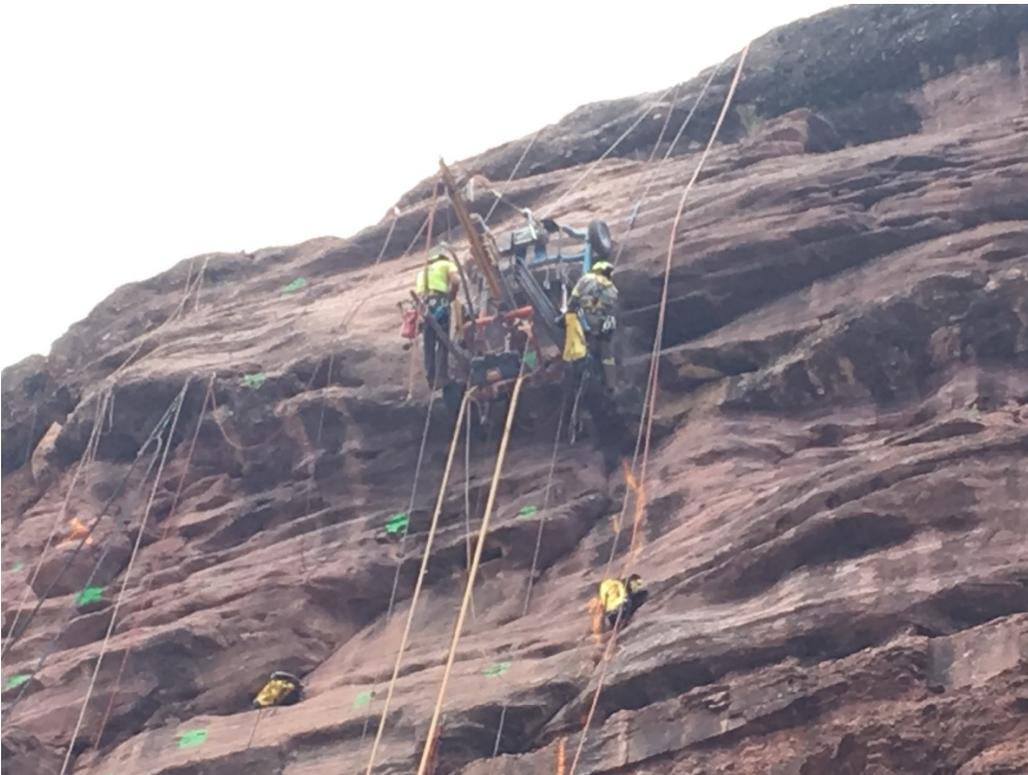
Photo 6. Drilling buggy on the upper slab.
